Manhole Inspection Summary

Manhole # S33I__005MH

Inspection ☐ Is Incomplete Rating: **2) Good**

Insp Date: **11/12/08 2:48 PM**

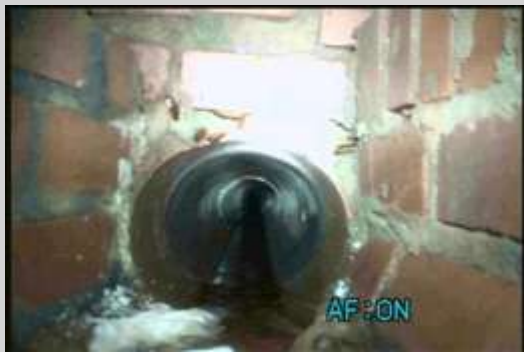
12 O'Clock Outflow

8 in. Circular Gravity Sewer
Pipe Out @ 12 O'Clock

Pipe Material: **Clay** ☐ Pipe Lined

Invert Depth: **18.50** (ft.) Flow Characteristics: **Slow**

Deposits: ☒ None ☐ Mud ☐ Sludge ☐ Debris ☐ Grease

Infiltration: **None** Pipe Seal Cond: **Unknown**

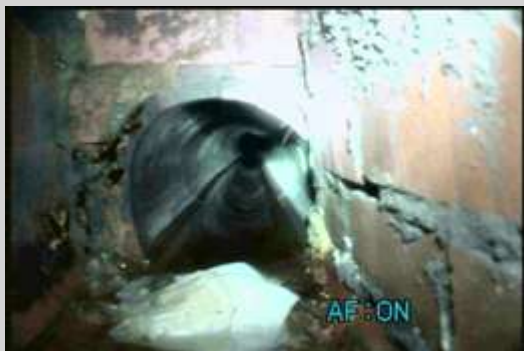
6 O'Clock Inflow

8 in. Circular Gravity Sewer
Pipe In @ 6 O'Clock

Pipe Material: **Clay** ☐ Pipe Lined

Infiltration: **None** Pipe Seal Cond: **Unknown**
